PETROGRAPHIC STUDY OF A BUILDING DETERIORATED DUE TO ALKALI-SILICA REACTION, IN BUENOS AIRES CITY (ARGENTINA)

The columns of a building from 1935, located in Buenos Aires city, show cracks that have put the whole structure at risk. A petrographic study was carried out in order to determine the origin of concrete deterioration.

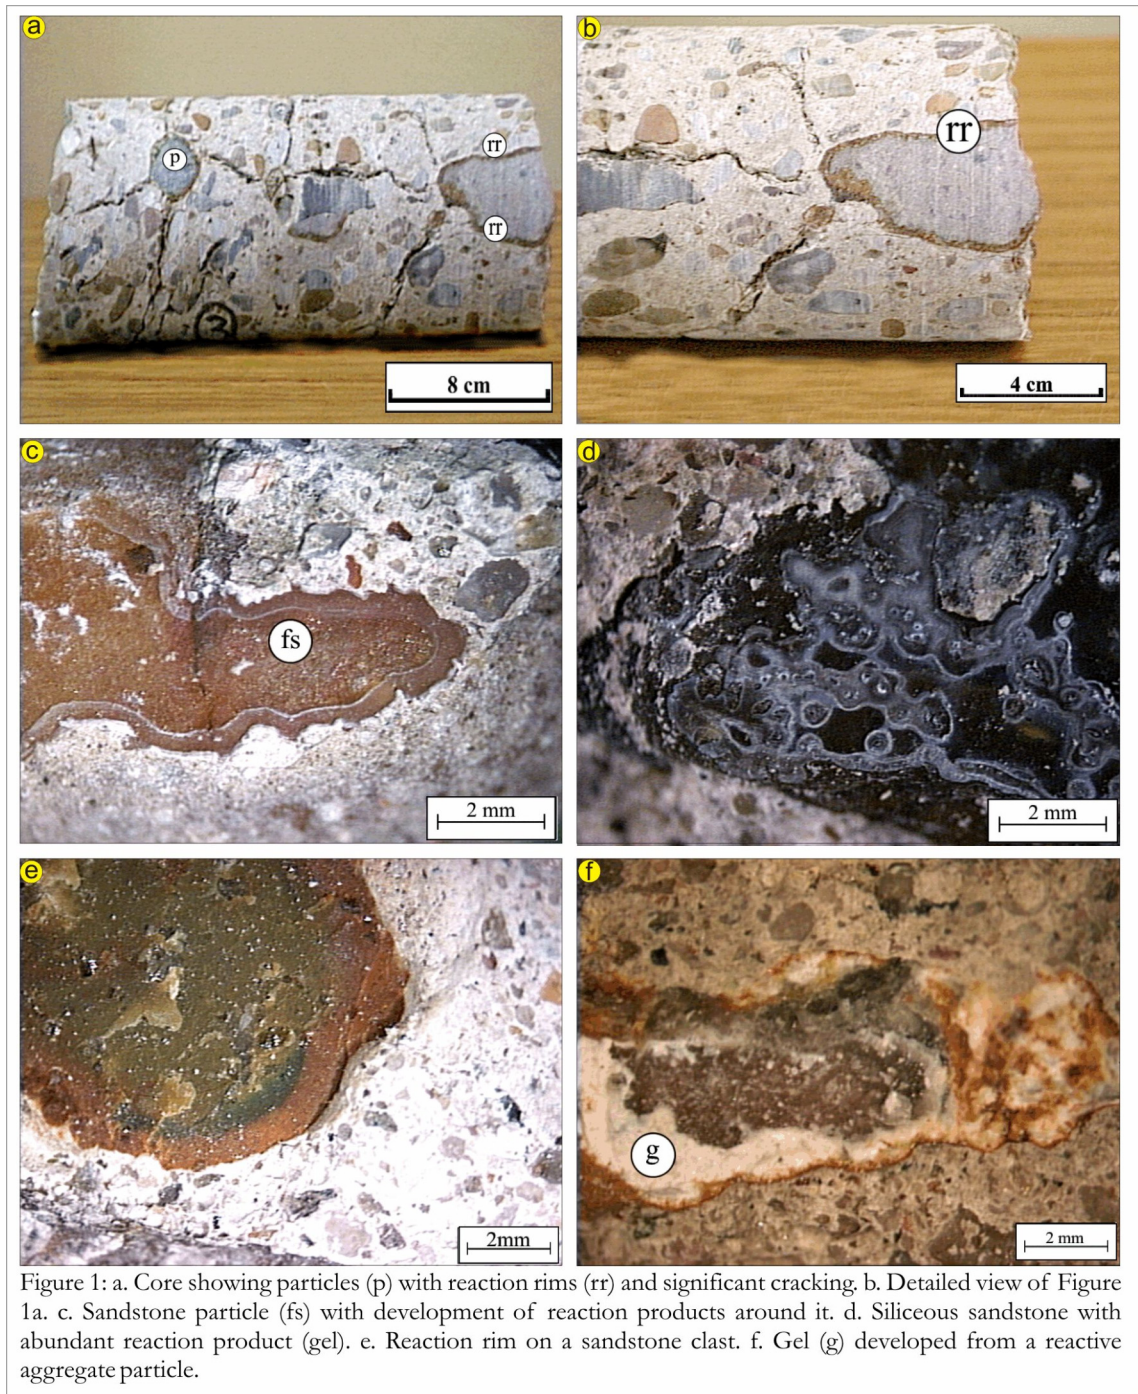
The morphological characteristics of the lithic components with reaction rims (rr) of the coarse aggregate are shown in Figure 1a. A particle (p) that has expanded after core drilling is shown; cracking is significant. Figure 1b is a detailed view of Figure 1a showing reaction rims (rr) in a gravel grain and cracking in three directions.

Figure 1c shows a sand grain of ferruginous sandstone (fs) with abundant reaction product in its boundary area. A gel mass that partially covers a reddish brown sandstone particle is depicted in Figure 1d. Figure 1e shows an aggregate particle with development of abundant reaction product. The surrounding cement past is cracked, causing the detachment of the particle. Abundant gel (g) that has developed in the reactive aggregate-cement paste interface is shown in Figure 1f.

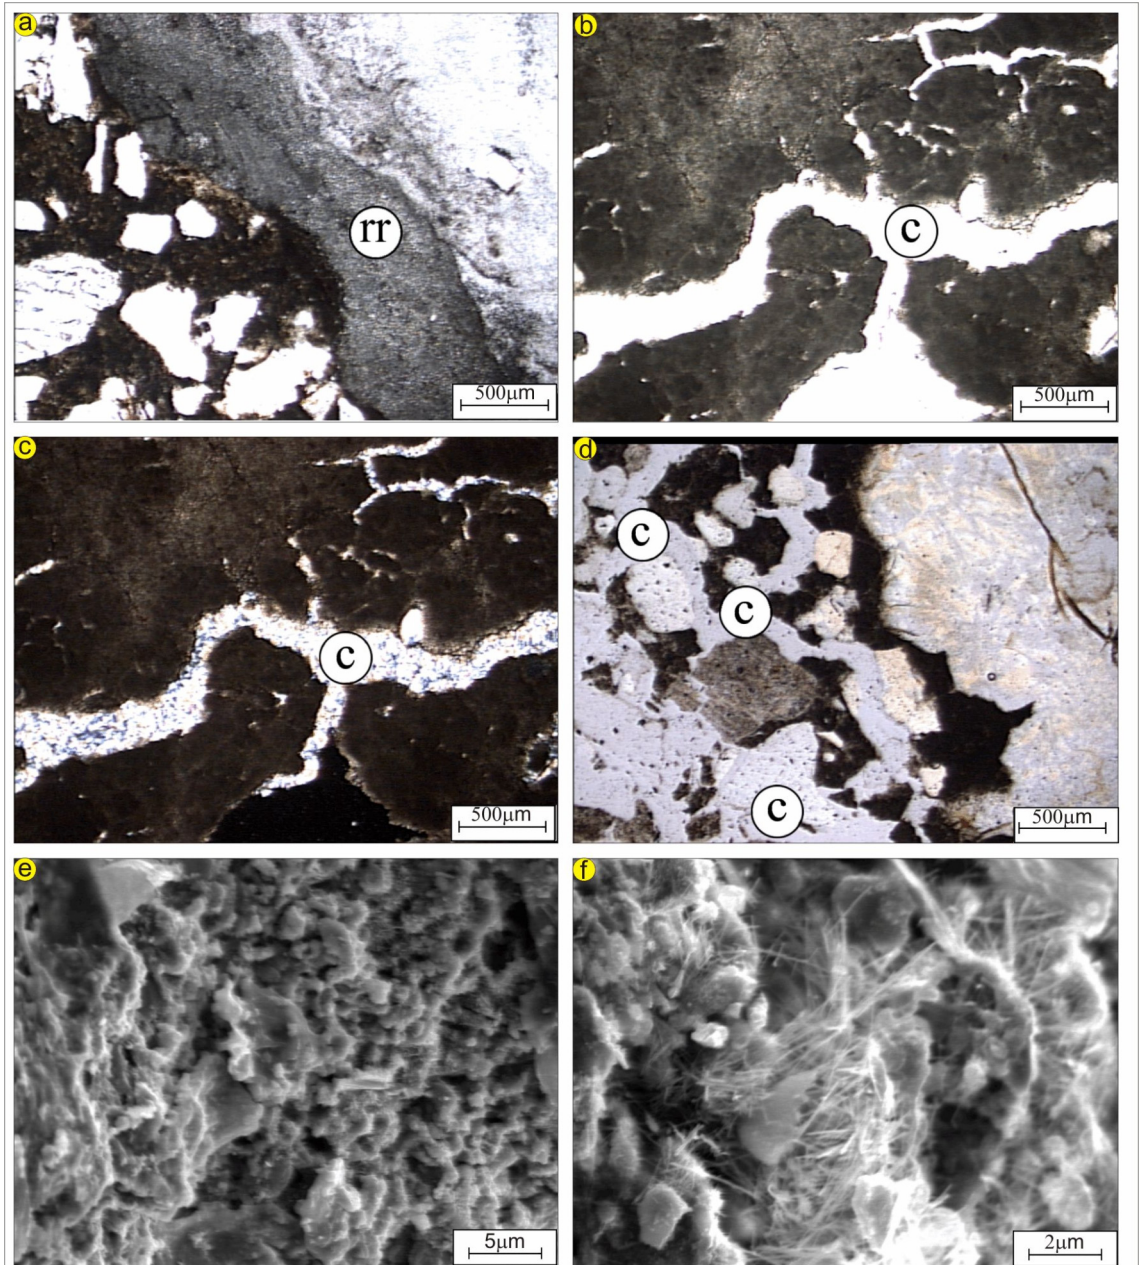
An aggregate-cement paste interface with reaction rim (rr) development is shown in Figure 2a. A crack (c) in three directions (viewed under plane polarized light) is depicted in Figure 2b. Figure 2c depicts the same crack viewed with cross polarized light to show that it is filled with an anisotropic reaction product that due to its optical properties can be assigned to zeolites with associated calcium carbonate (calcite). Figure 2d shows a highly cracked mortar area (c) with its texture completely obliterated.

The material analysed was developed at the reactive aggregate-cement paste interface and inside the microcracks. Figure 2e shows a SEM image of the ASR product. In the EDS analysis Si, Al, O, Ca and minor amounts of K and Na were identified (Figure 3a). A zeolitic structure belonging to the clinoptilolite-heulandite group ($\text{KNa}_2\text{Ca}_2(\text{Si}_{29}\text{Al}_7)\text{O}_{72}\cdot 24\text{H}_2\text{O}$) comparable to the ICDD card number 39-1383 was determined by X-ray diffraction [1]. The main reflections were identified at 8.90 Å and 3.97 Å. The diffractogram is presented in Figure 3b. Figure 2f shows the material developed inside air voids and cracks. Its chemical composition, analysed by EDS, is S, Al, Ca and O (Figure 3c). An ettringite structure ($\text{Ca}_6\text{Al}_2(\text{SO}_4)_3(\text{OH})_{12}\cdot 26\text{H}_2\text{O}$) comparable to the ICDD card number 41-1451 was identified by X-ray diffraction. The main reflections appear at 9.7 Å and 5.6 Å (Figure 3d).

Figure 2: a. Aggregate-cement paste interface showing the development of a reaction rim (rr). b. Microcracking in three directions (c) (viewed under plane polarized light). c. The same image as the above viewed with cross polarized light. d. Cement paste with significant microcracking. e. Gel morphology viewed with SEM. f. Ettringite morphology viewed with SEM.

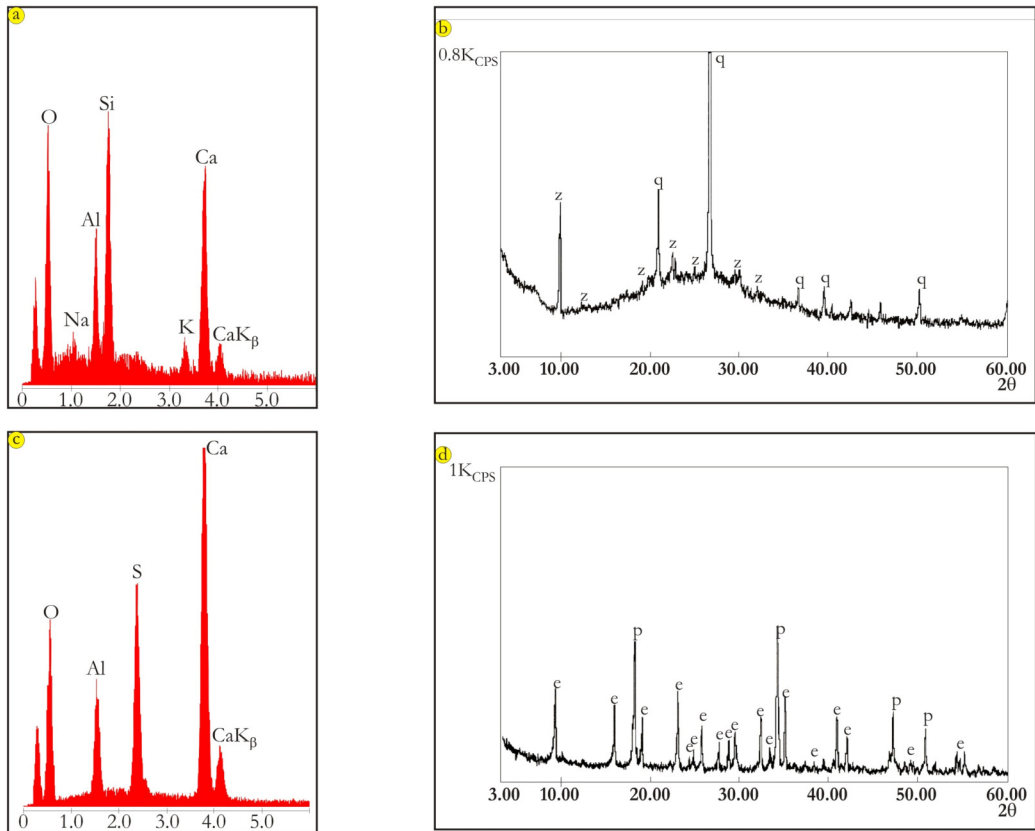
Figure 3: a. EDS of the material observed in figure 2e. b. XRD of the product of ASR. z: zeolite, q: quartz. c. EDS of the material observed in figure 2f. d. XRD of ettringite (e) with portlandite (p) development on the concrete surface.
