IDENTIFICATION OF ZEOLITES IN CONCRETES AFFECTED BY ASR.
EFFECT OF DIFFERENT AGGREGATES.

Maiza, P., Marfil, S. and Batic, O.
Geology Department, UNS. LEMIT-CIC.
CONICET. CIC. Argentina.

Three concretes from structures damaged by alkali aggregate reaction were studied. They were prepared with different aggregates: sandstone, granite (in both of them grains of quartz showed signs of deformation) and the third one mainly constituted by vulcanites. Thin cuts from concretes were analyzed with the petrographic microscope. Zeolites were identified as the main reaction product. They present the same optical characteristics in the three cases. Zeolites correspond to the group of clinoptilolite - heulandite (by XRD). They were also observed at SEM and analyzed by EDAX.

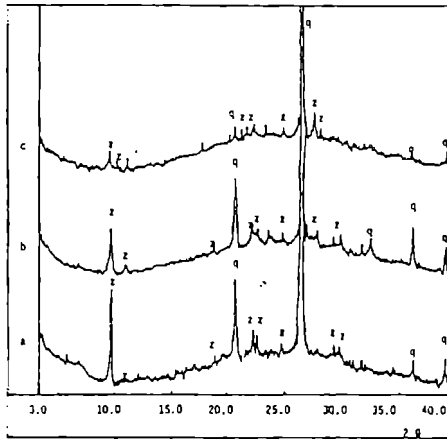
z: zeolite
q: quartz

Figure 1 Diffractograms of the reaction products.
a) Concrete N 1, b) Concrete N 2, c) Concrete N 3

To identify the reaction products observed with the petrographic microscope, 10 thin cuts from each concrete were prepared. The reaction product was separated with the help of the microscope, by the picking method. Near 10 mg of zeolite, with the maximum purity that possible, were obtained to be analyzed by XRD. Table 1 shows the results corresponding to Concretes 1, 2 and 3. In the three cases the zeolite is accompanied by the quartz of the aggregate and calcite from the reaction in concrete.

Diffractograms corresponding to Concretes N 1, N 2 and N 3 are shown in Fig.1 a, b and c respectively, identifying in all cases a zeolite of the group of the heulandite - clinoptilolite.

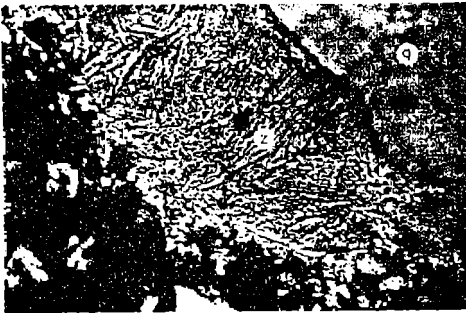
Micrograph 1 Stressed quartz (q) with zeolites (z) at the border. (x300)

Concrete N 1. Grains of aggregates from concrete are constitute principally by quartz (q), cemented with polycrystalline silica, with undulatory extinction, in some of them there are zeolites (z) at their external part, (Micrograph 1, x300). Others present borders of reaction (b) and contact of "caries" with portland cement. There are many fissures in the paste. In air voids (c), the same as in part of the paste (p), there are zeolites as it can be seen in Micrograph 2 (x125).
