Algal Community Structure of the Yalour Mausoleum, Cemetery of La Plata, Buenos Aires, Argentina

Rapid Communication

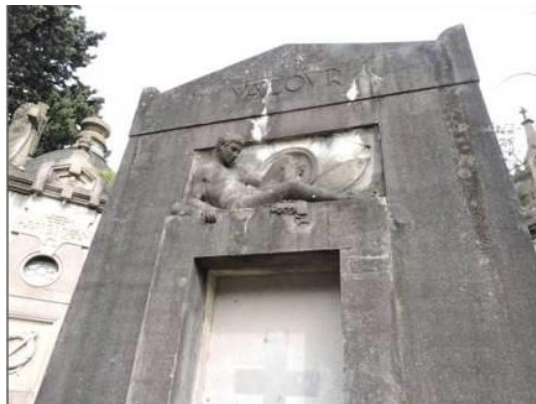
The Yalour mausoleum is located in the Cemetery of La Plata, Buenos Aires, and Argentina. It is a monument of 3.25 m front made of reinforced concrete and it presents in the front a sculpture of a marine scene FIG. 1. Samples were taken at 4 sites on the walls by scraping with sterile scalpel and from the glasses of the mausoleum. In the laboratory, portions of each sample were separated for observation and taxonomic determination of the algae under the optical microscope (Arcano), in the scanning electron microscope (FEI, Quanta 200) and in the epifluorescence microscope (Olympus BX51). The rest of the samples are kept in culture broth BG11.

FIG. 1. Mausoleum of Yalour.

After having characterized the phototrophic biofilm developed in the Yalour mausoleum, as shown in this paper, *in situ* assays will be carried out with different cleaning techniques, taking into account not to alter the surface of the mausoleum, as well as methods of prevention to delay and minimize future re-colonization.
