BIODEGRADATION AND BIODETERIORATION OF WOODEN HERITAGE: ROLE OF FUNGAL SUCCESSION

Paula Vanesa ALFIERI*, Renato GARCÍA, Vilma ROSATO, María Verónica CORREA

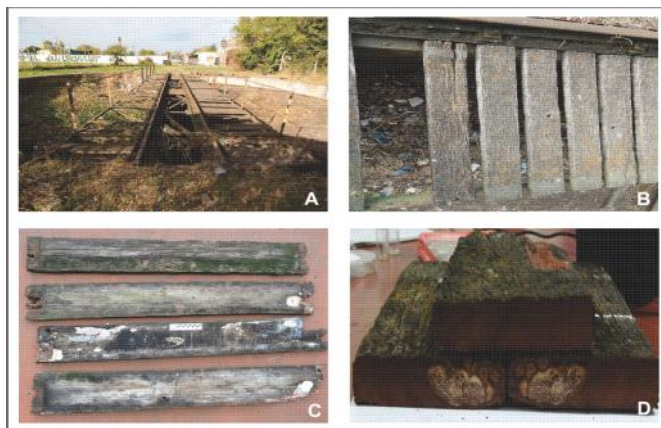
Fig. 2. Detail of locomotive turntable status:

- A - Structure consists in wooden slats of *Schinopsis* sp. within metal framework;
- B - slats in advanced status of deterioration caused by environmental and biological factors;
- C - Samples acquired for simulating the same degradation status than wooden turntable in laboratory;
- D - Detail of wood decay fungi found and its biodegradation (inside view).

This paper was based on the current status of the locomotive turntable found in the Provincial Railway Station La Plata. It was inaugurated on April 27, 1910 and it was declared as architectural heritage in 2006 (Fig. 1). The locomotive turntable is 200 meters from this station (34° 56'16'' S and 57° 56'13'' W) and it is a structure that consists in wooden slats of *Schinopsis* sp. into metal framework [12, 13]. Currently, this structure is in an advanced status of degradation caused by environmental and biological factors, as shown in Figure 2. This was used as a model of biodegradation process.
